Manhole Inspection Summary

Manhole # S13CC2002MH

Insp Date: **7/26/06 8:36 AM**

Location Address: **2210 SULGRAVE AVE**

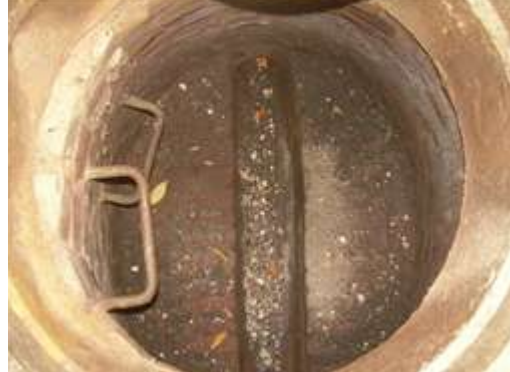
Top View

Bench and Channel debris.

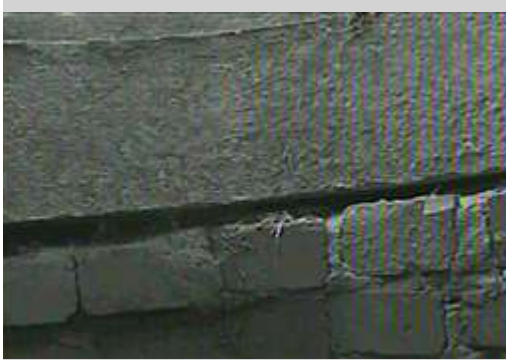
Defect

Frame leaks. Adjustment root intrusion, deterioration, and infiltration.

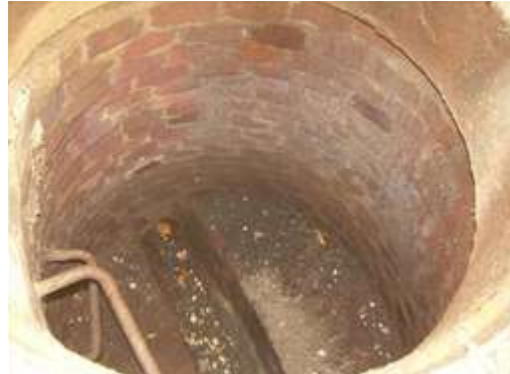
Defect

Frame leaks. Frame offset. Adjustment and Corbel infiltration.

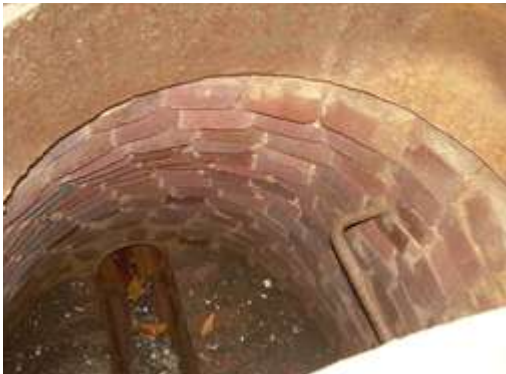
Defect

Frame leaks. Adjustment and Corbel infiltration - other side

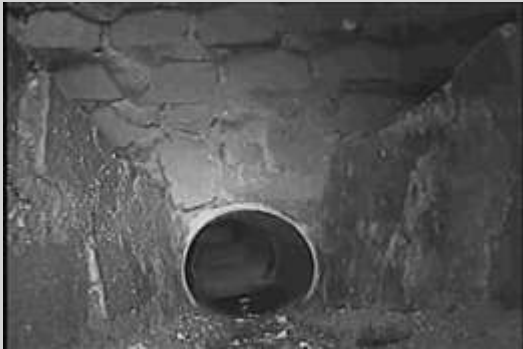
6 in. Circular Gravity Sewer Pipe Out @ 12 O'Clock

Barrel infiltration.

Deposits: ☐ None ☒ **Mud** ☐ Sludge ☒ **Debris** ☐ Grease

Silt Depth: **0.5** (in.) Deposits Extent: **Light**
